Manhole Inspection Summary

Manhole # S59Q__006MH

Insp Date: **7/25/08 11:59 AM**

Location Address: **4300 boston st**

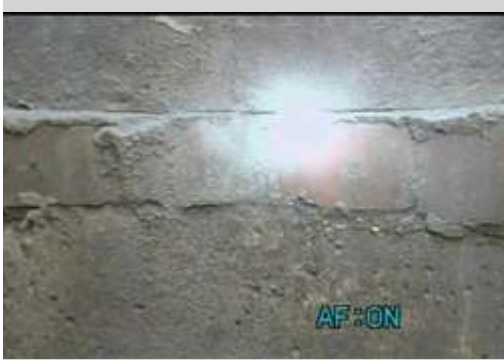
Defect 1

Condition: ☐ Sound ☒ **Cracked** ☐ Root Intrusion ☐ Loose Brick ☐ Deteriorated

Chimney cracked,
frame adj

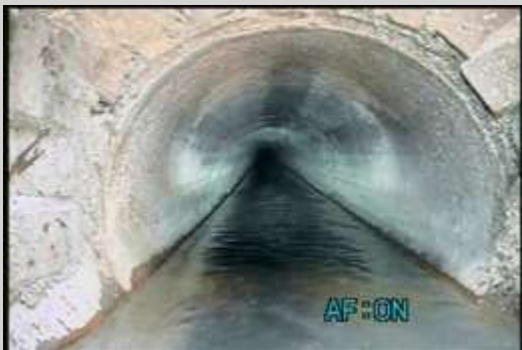
12 O'Clock Outflow

15 in. Circular Gravity Sewer
Pipe Out @ 12 O'Clock

Infiltration: **None** Pipe Seal Cond: **Unknown**

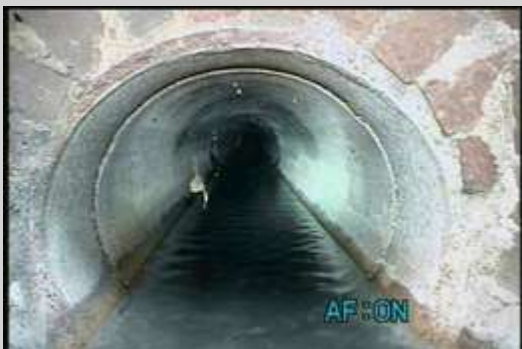
6 O'Clock Inflow

15 in. Circular Gravity Sewer
Pipe In @ 6 O'Clock

Infiltration: **None** Pipe Seal Cond: **Unknown**
